## Case Study 1

# Buried Framing

### Summerland, BC

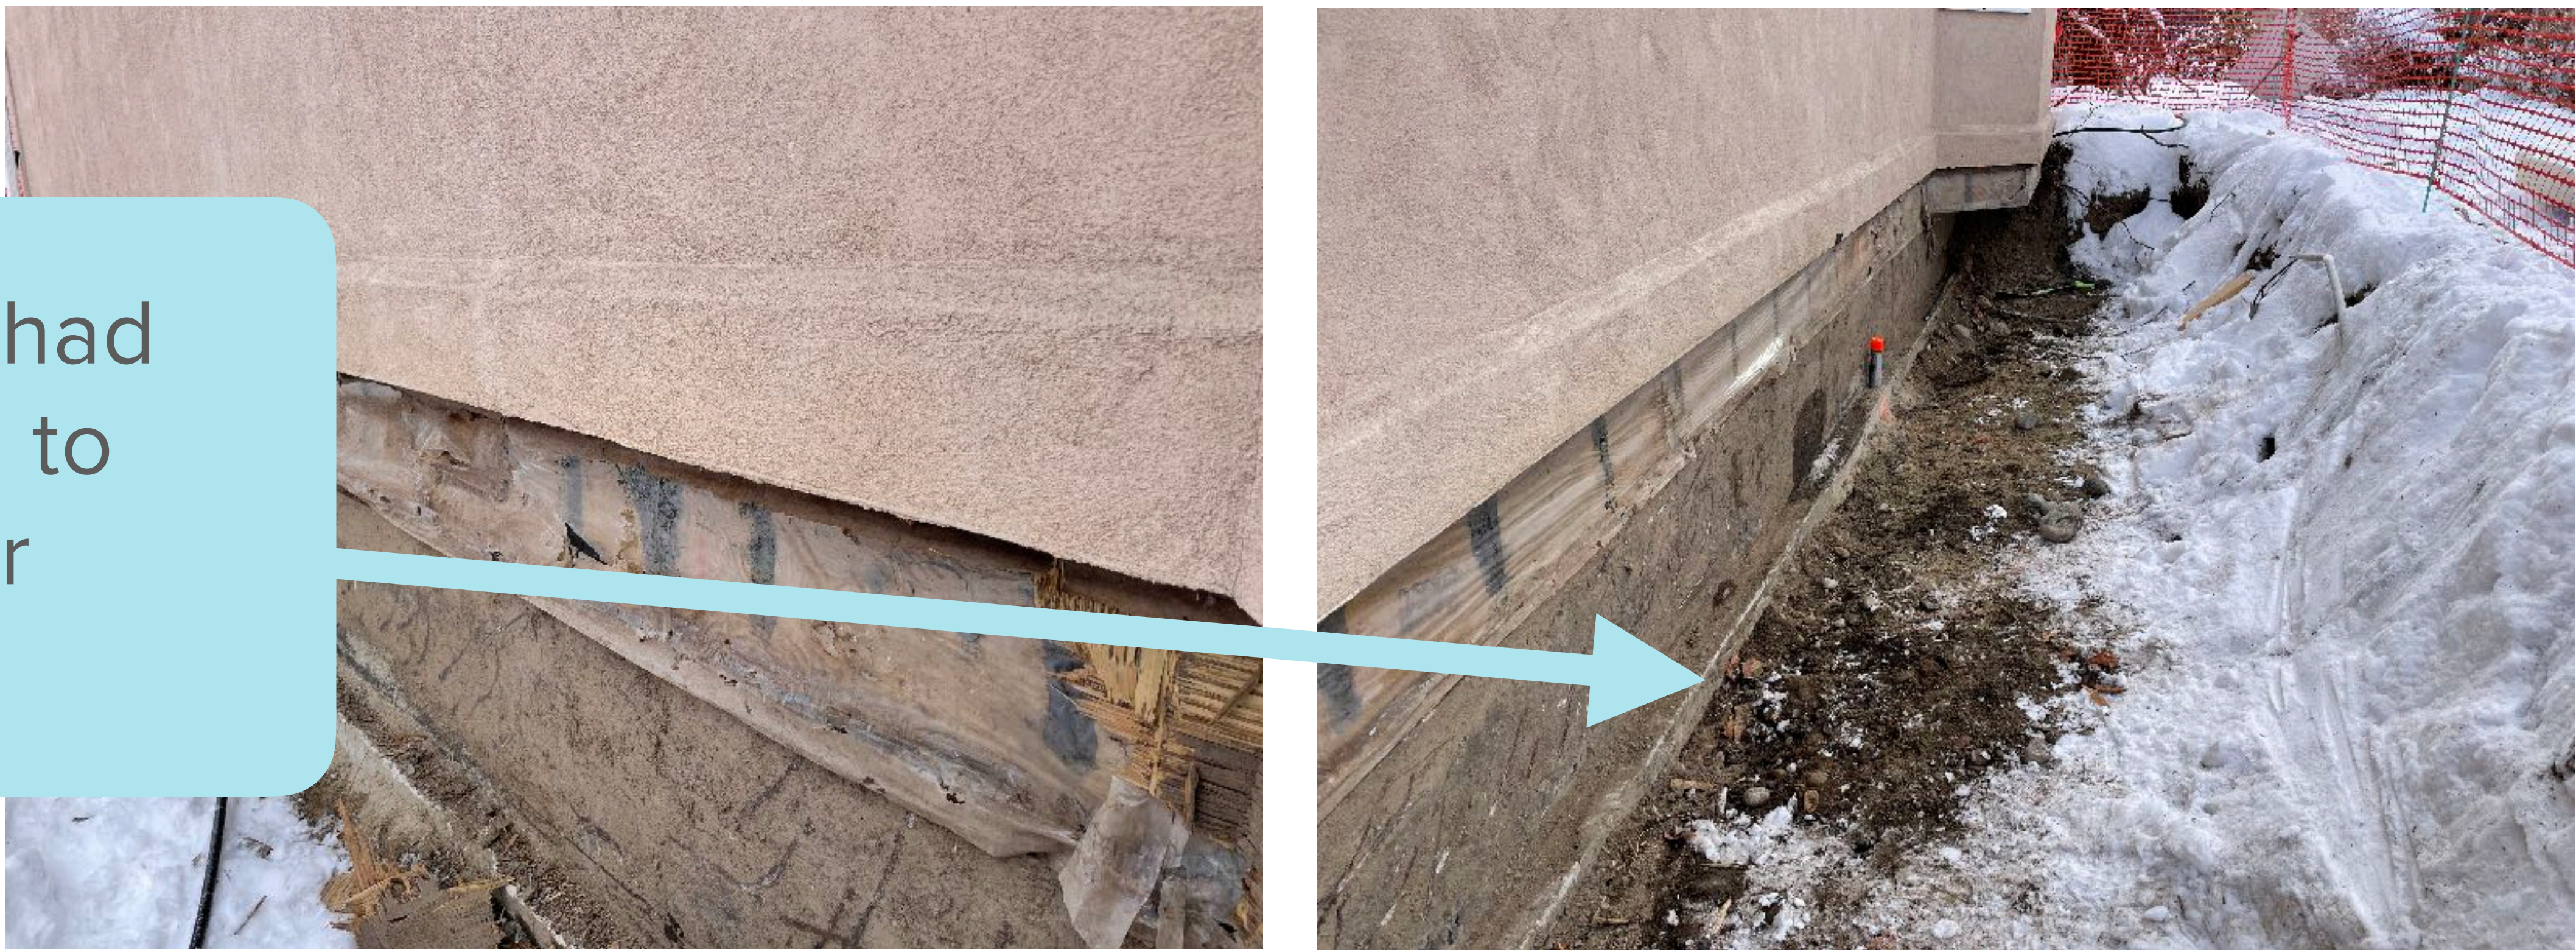
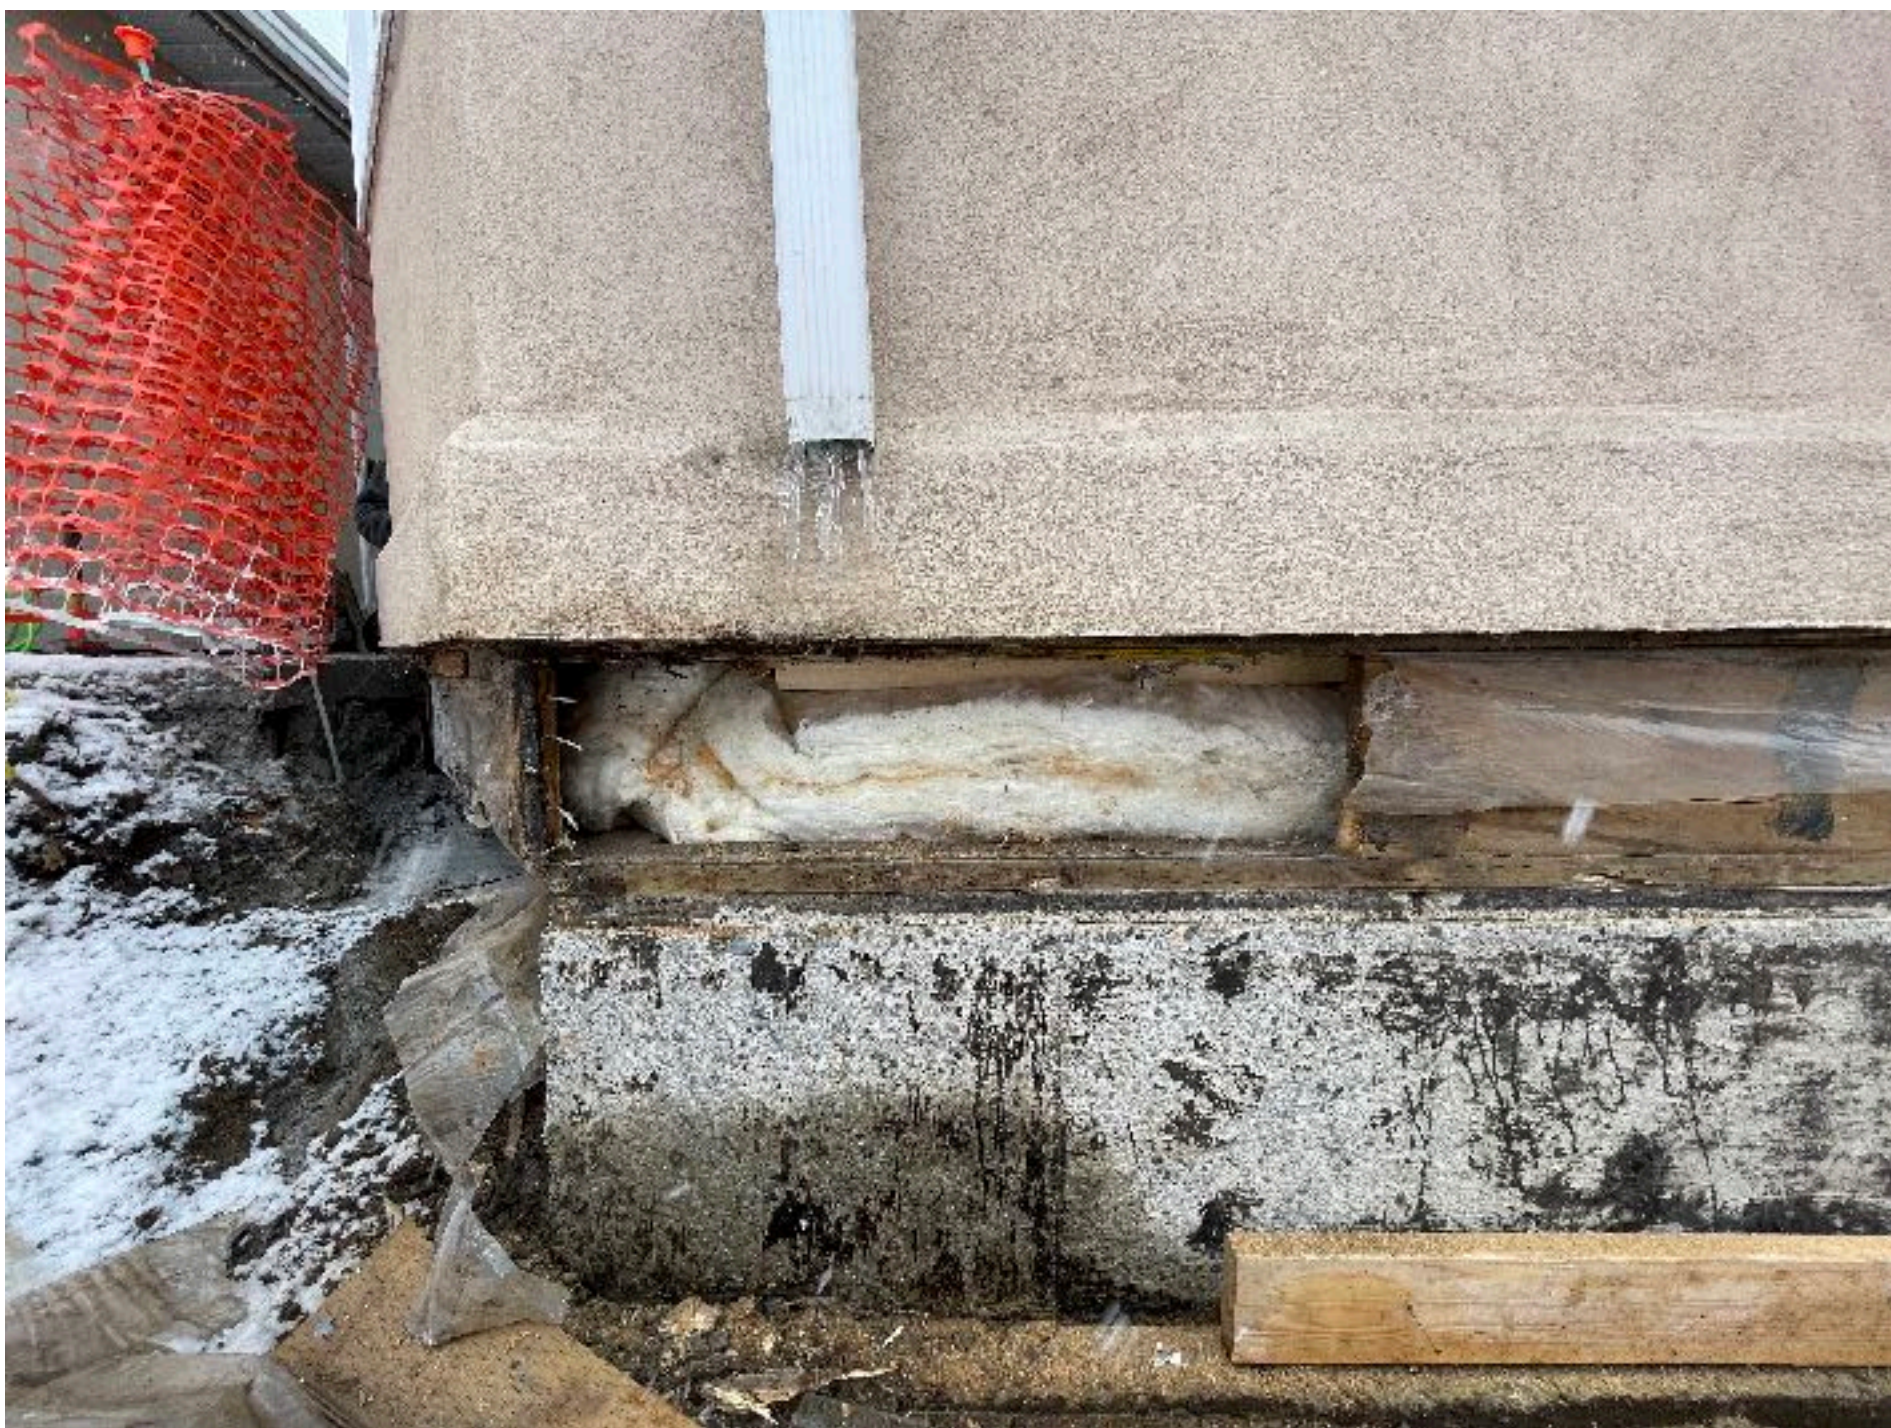
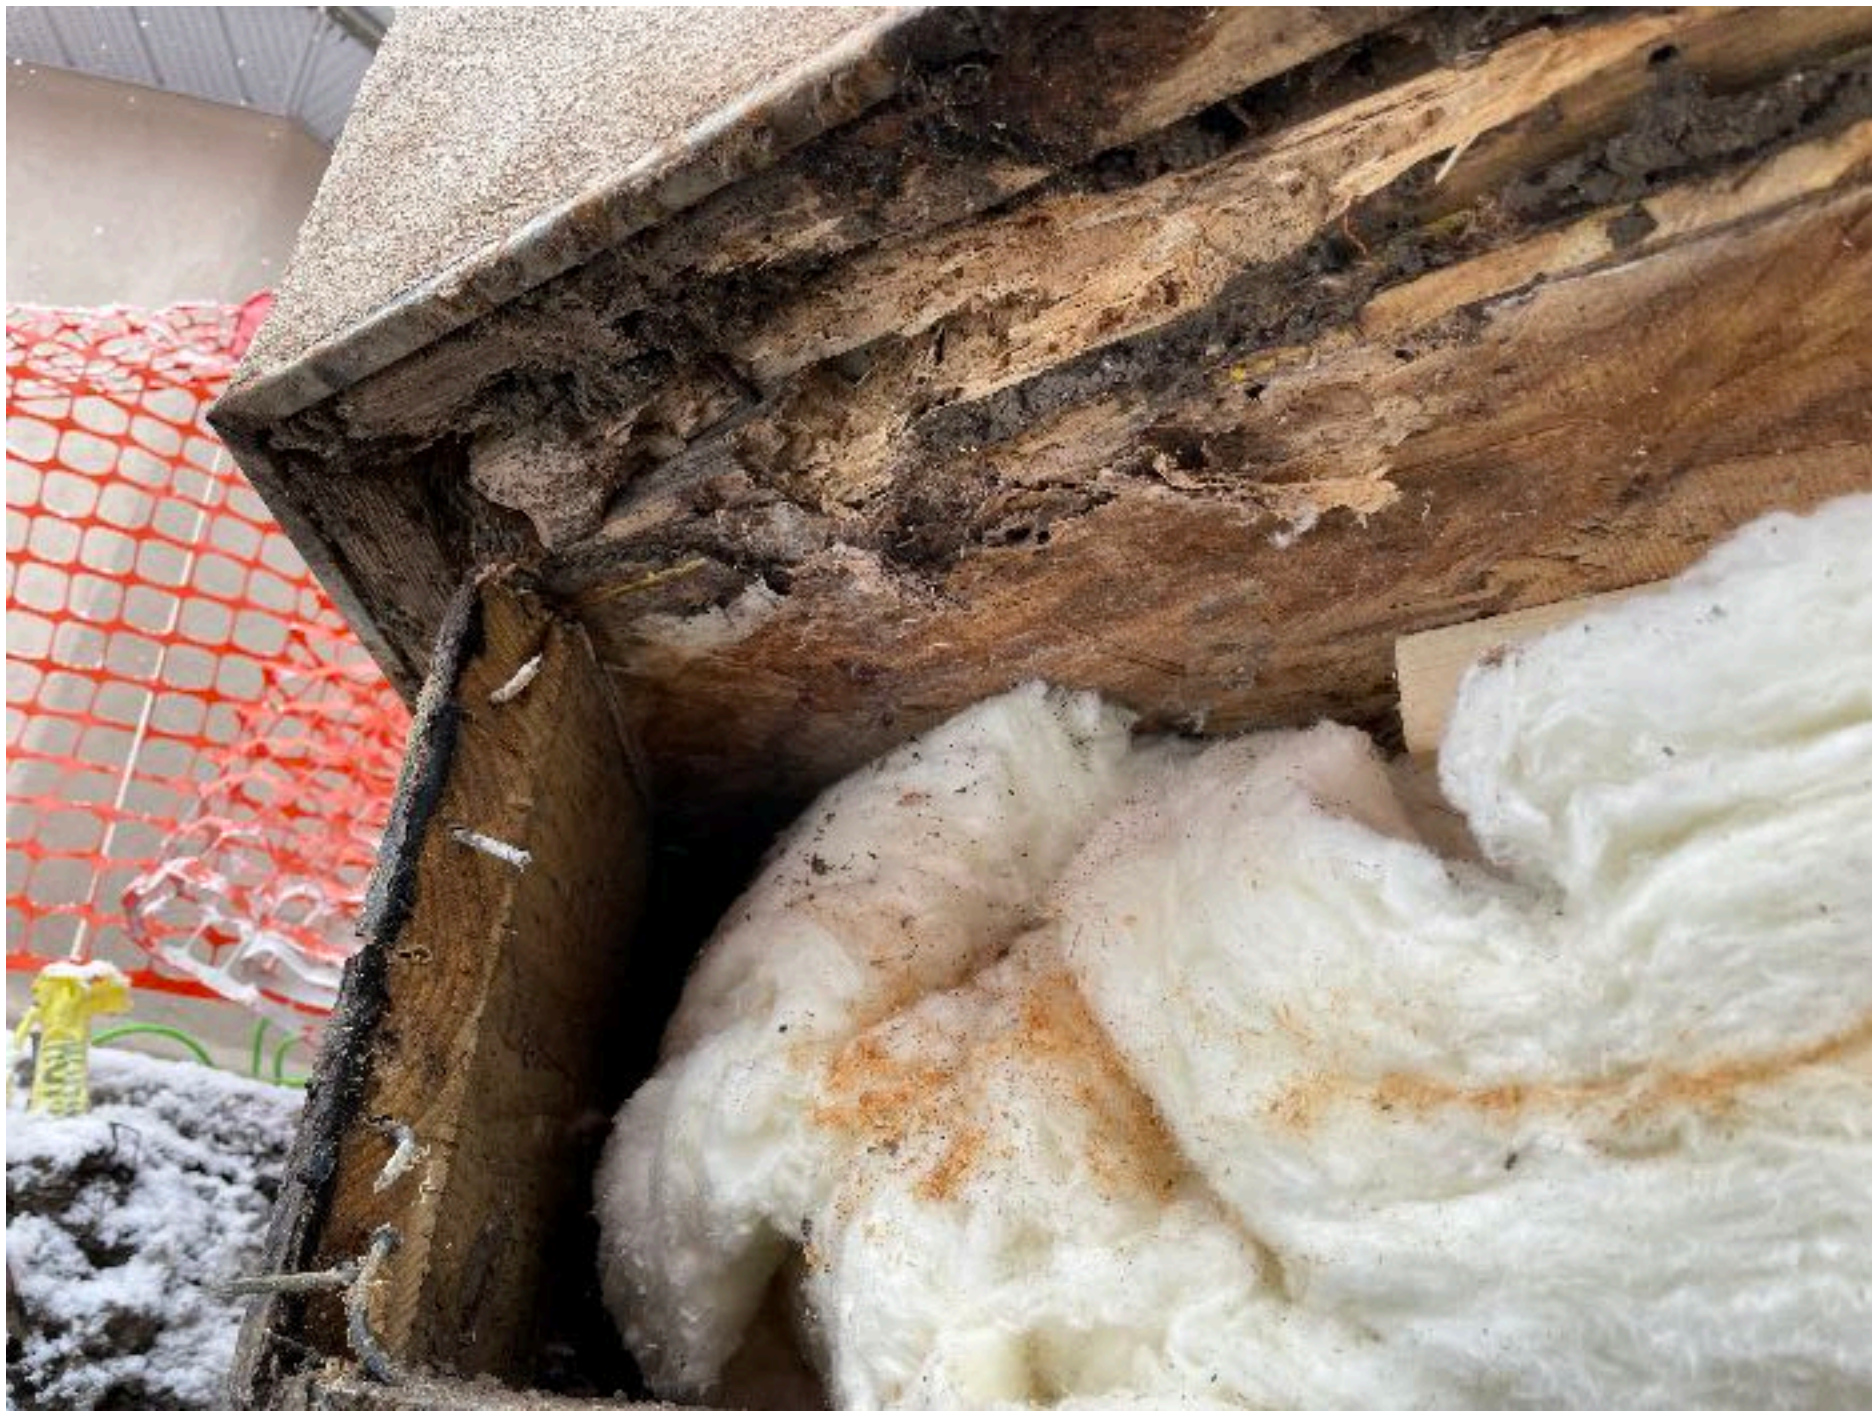
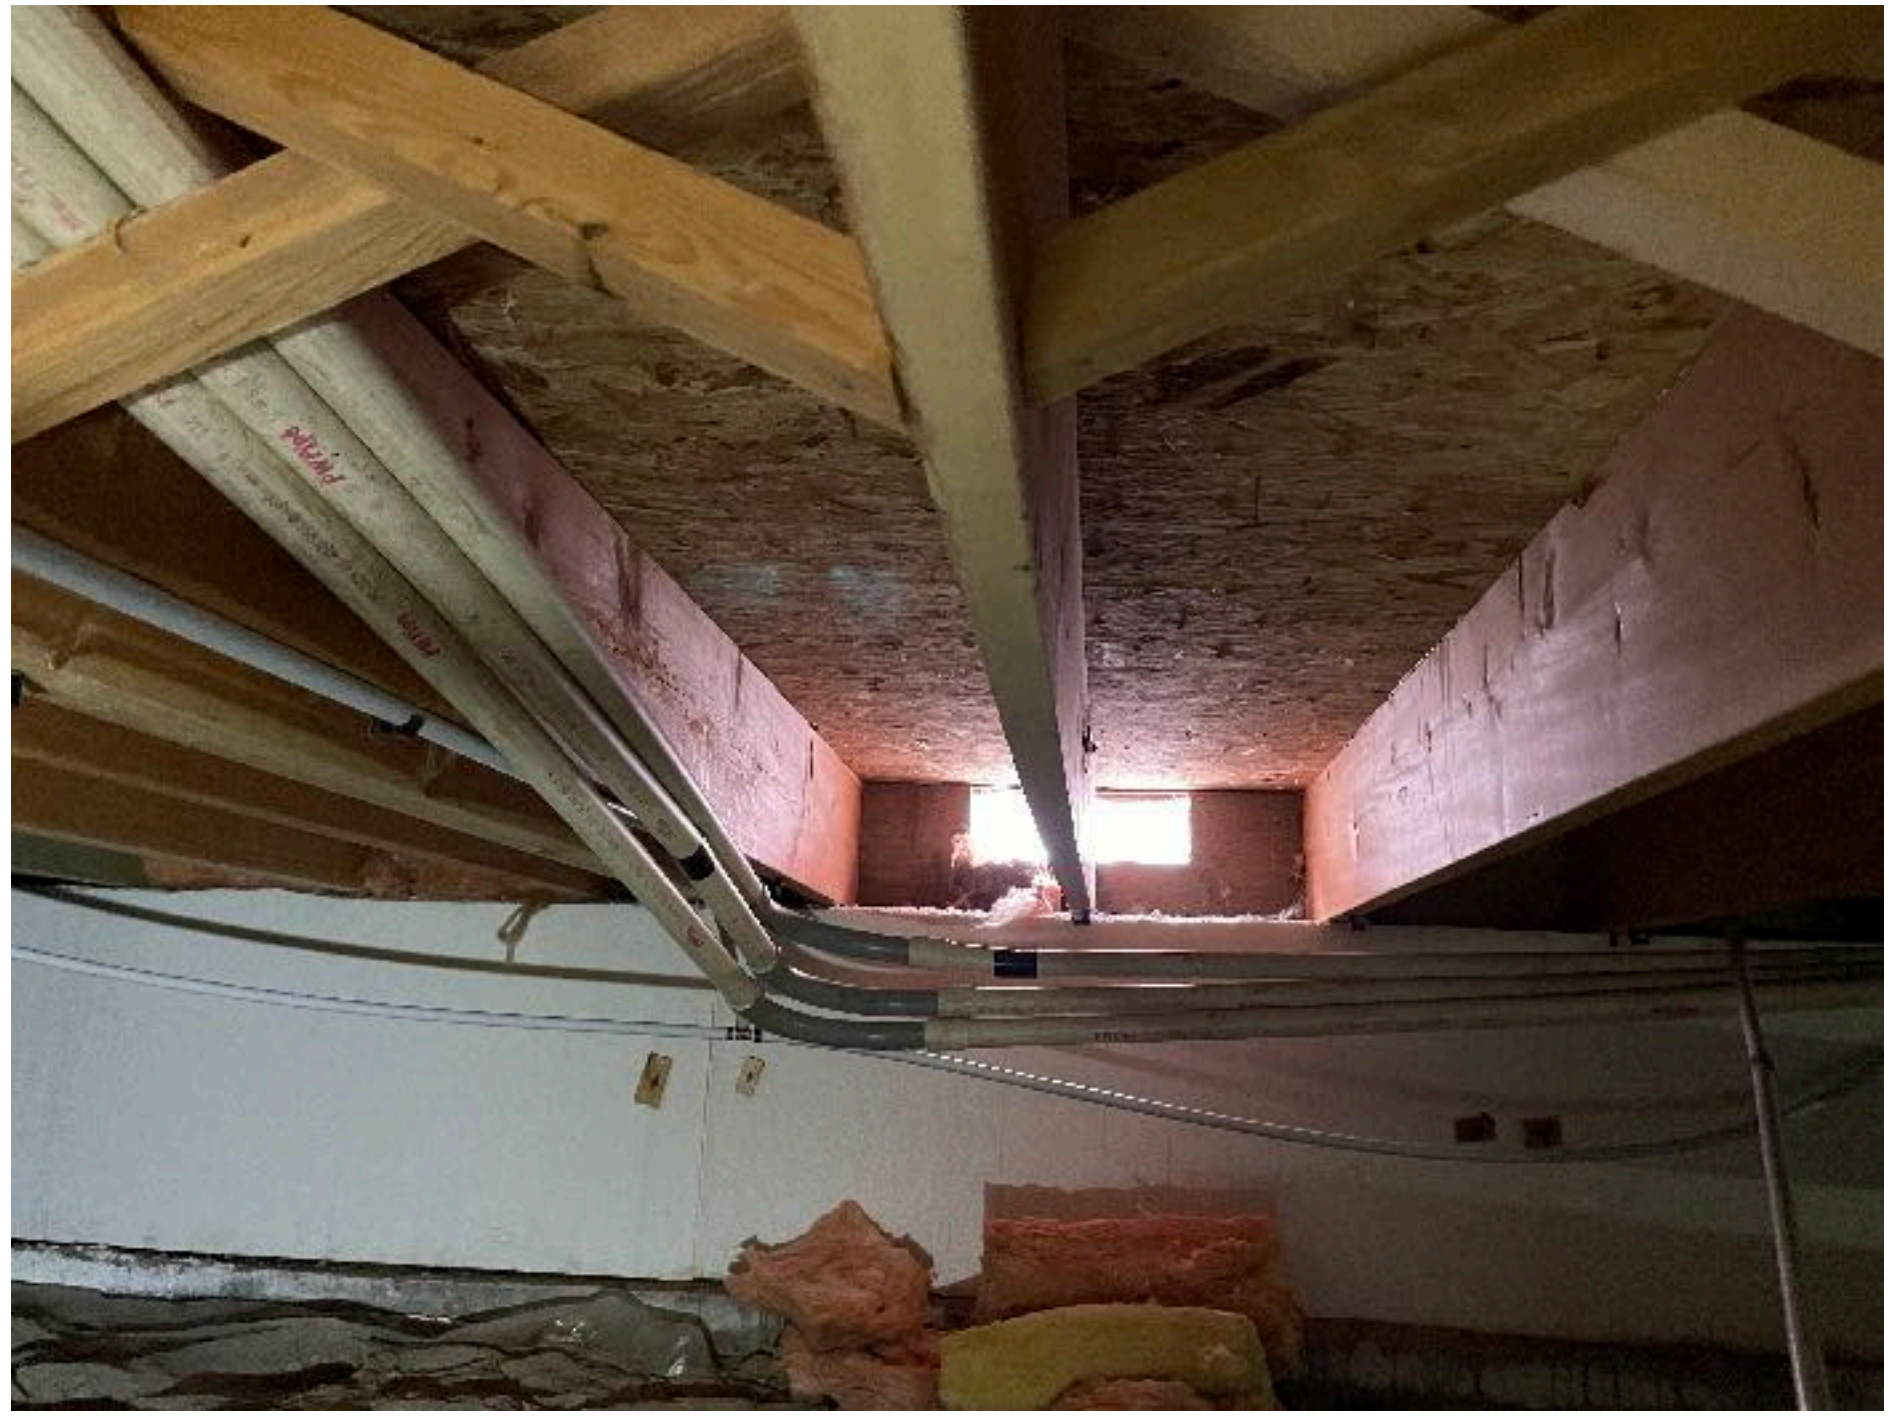
The side of the home had been excavated down to the footing prior to our arrival on-site.
