## Case Study 1

# Buried Framing

### Summerland, BC

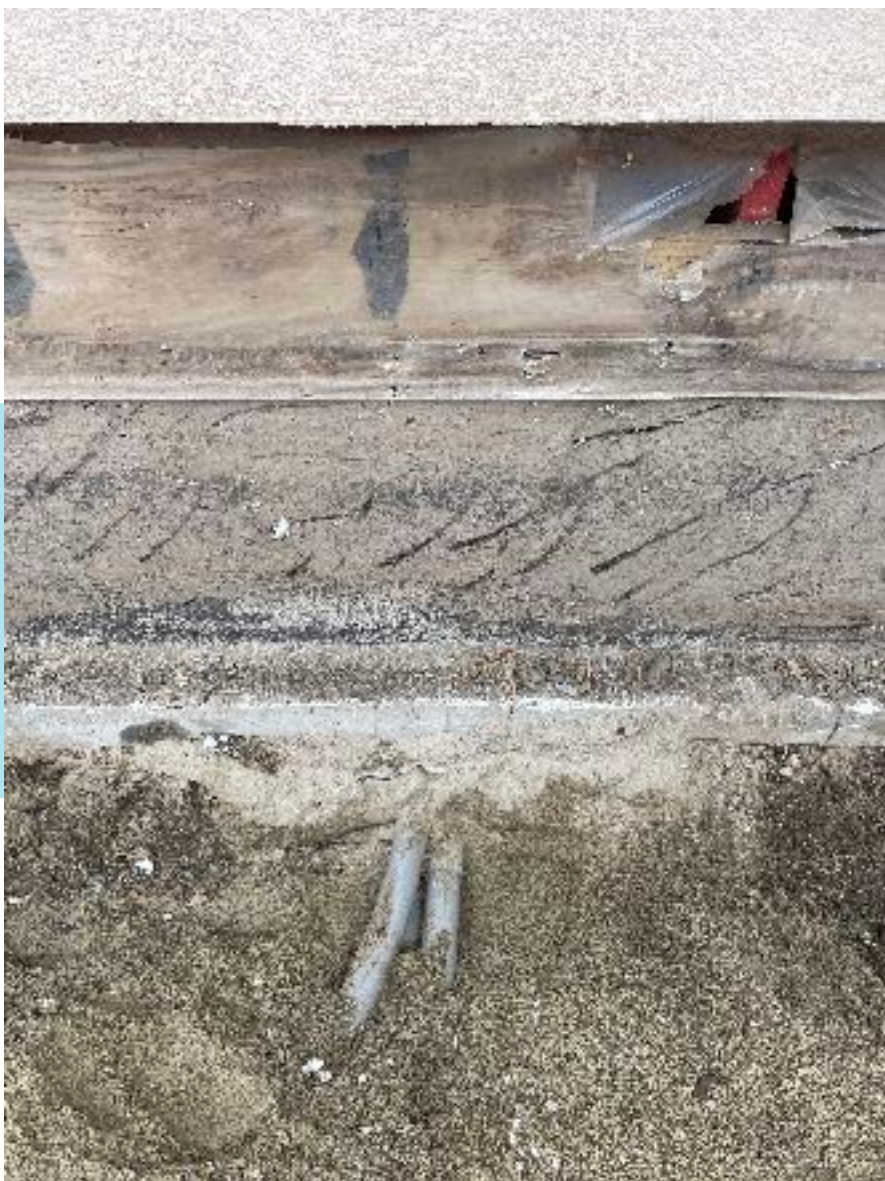
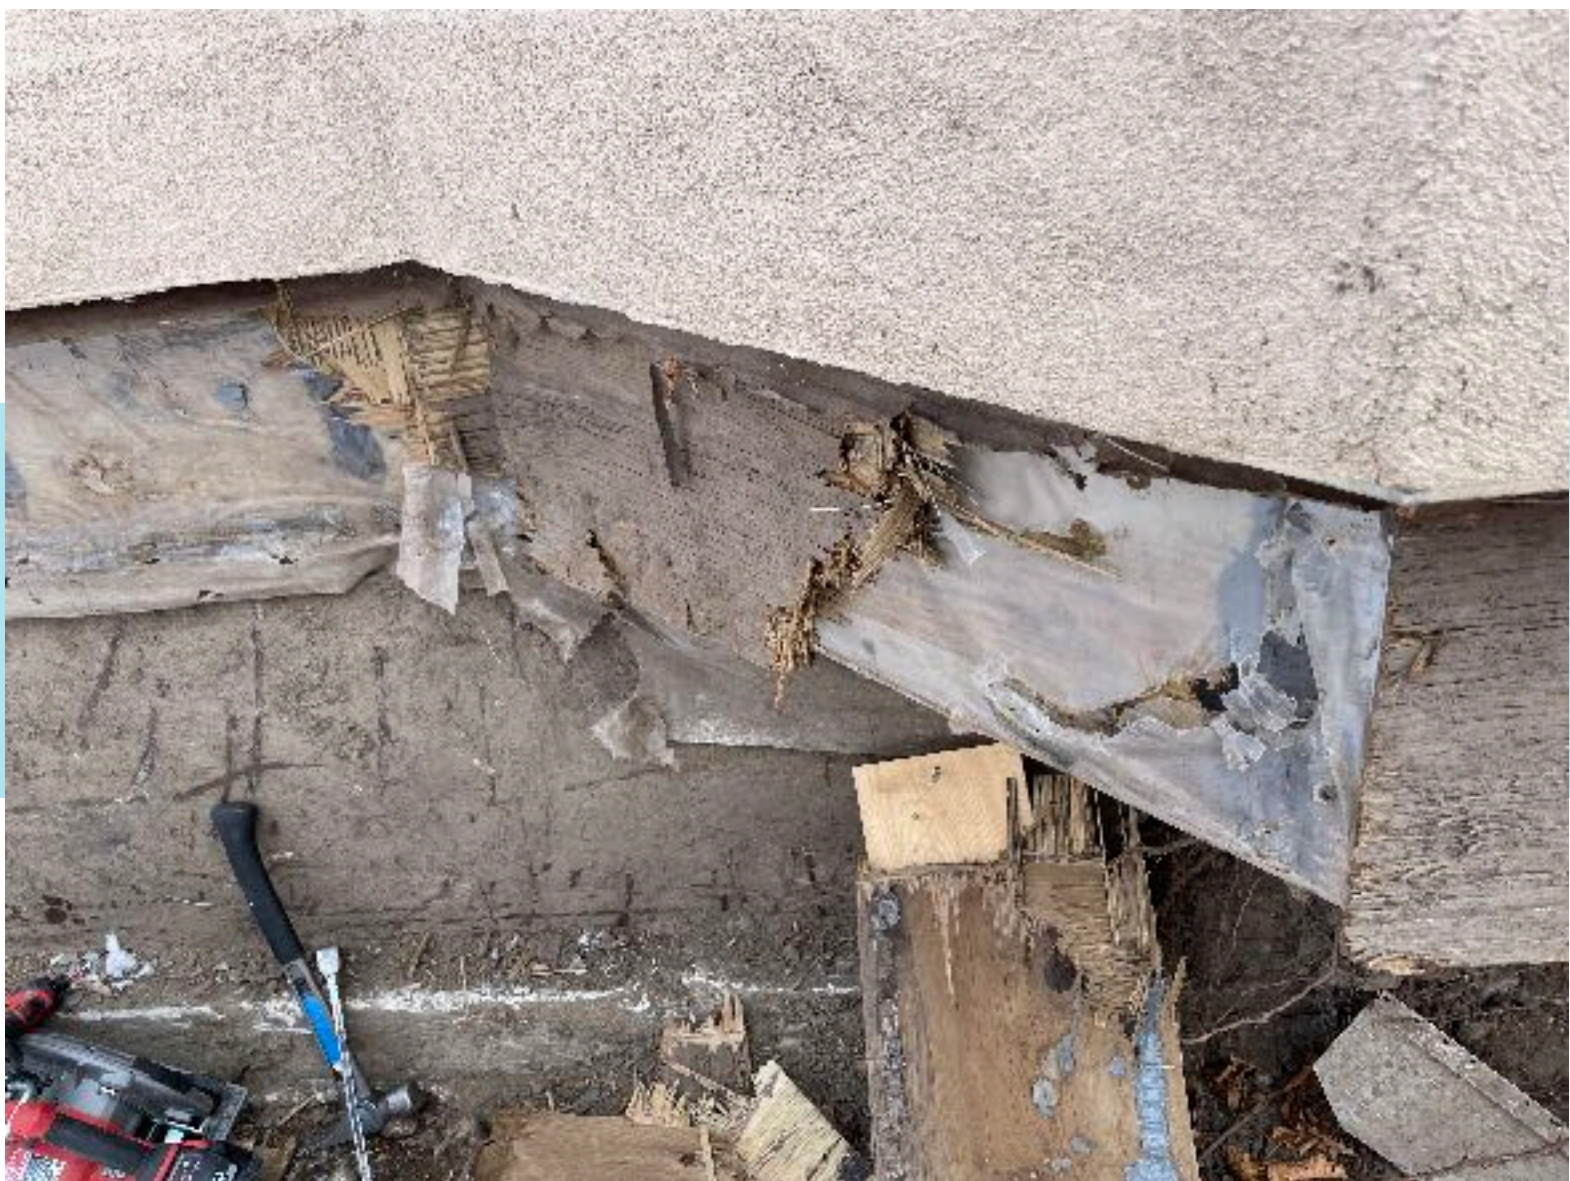
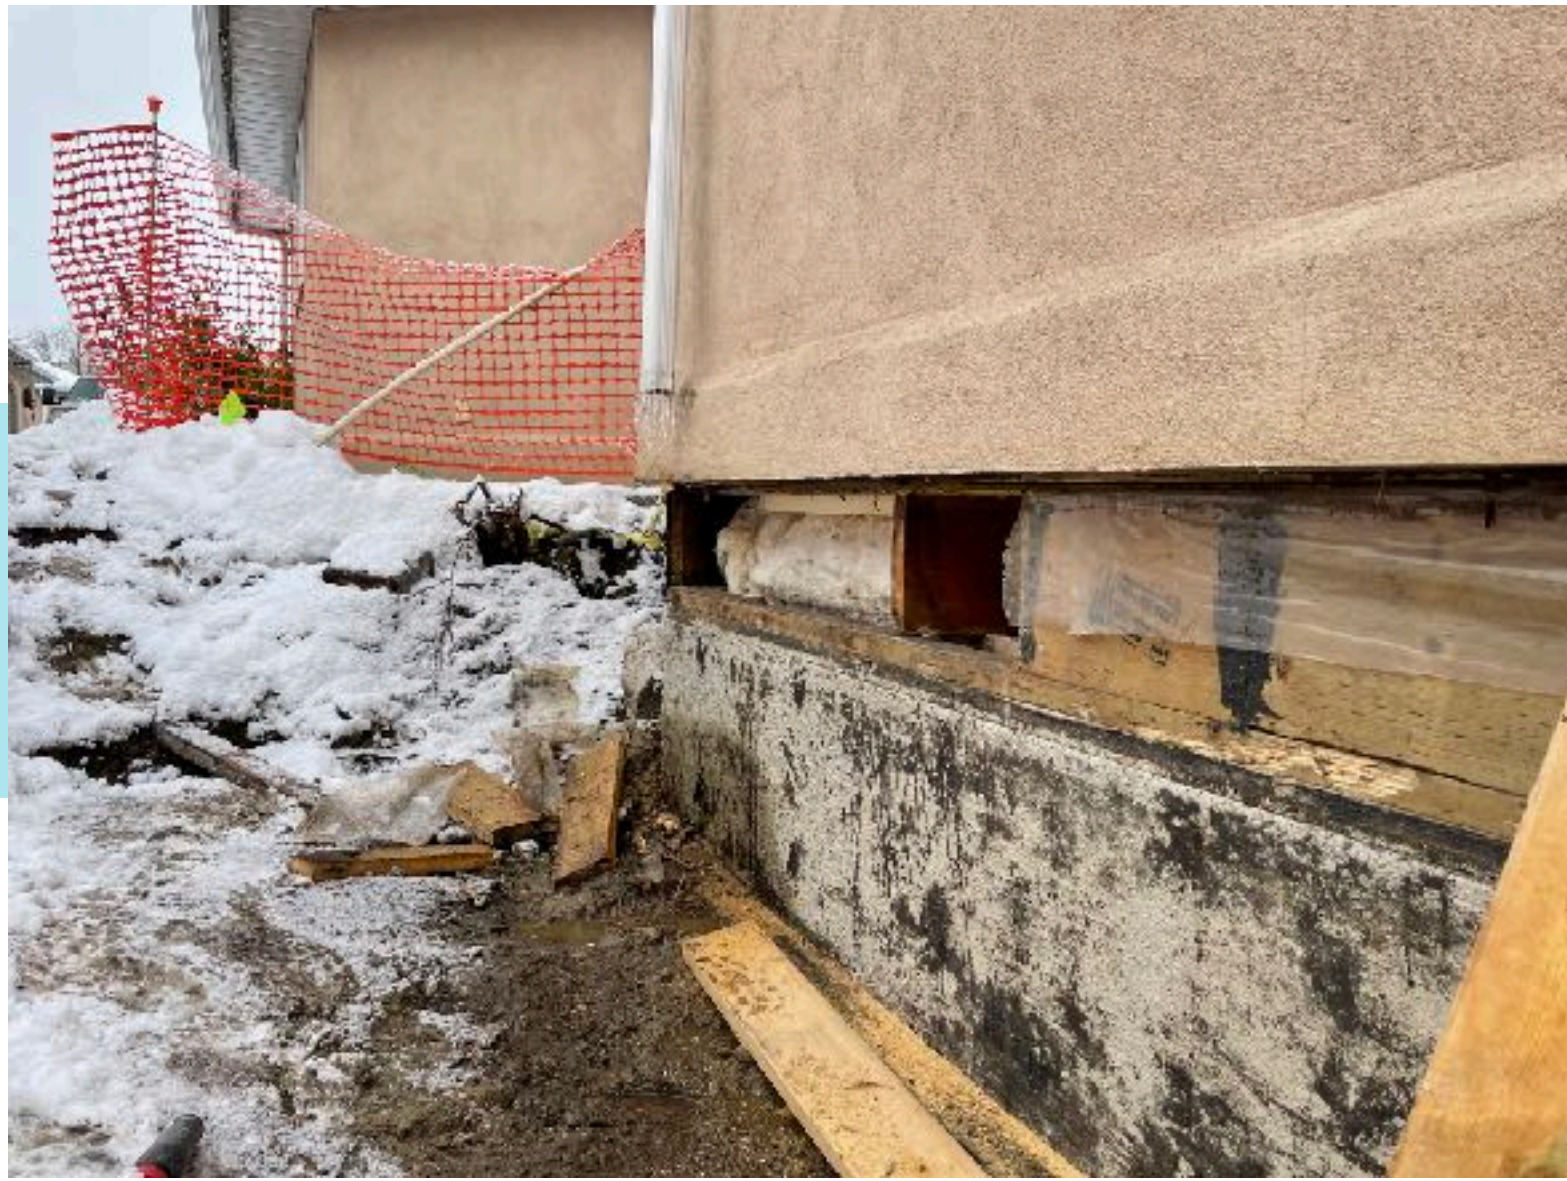
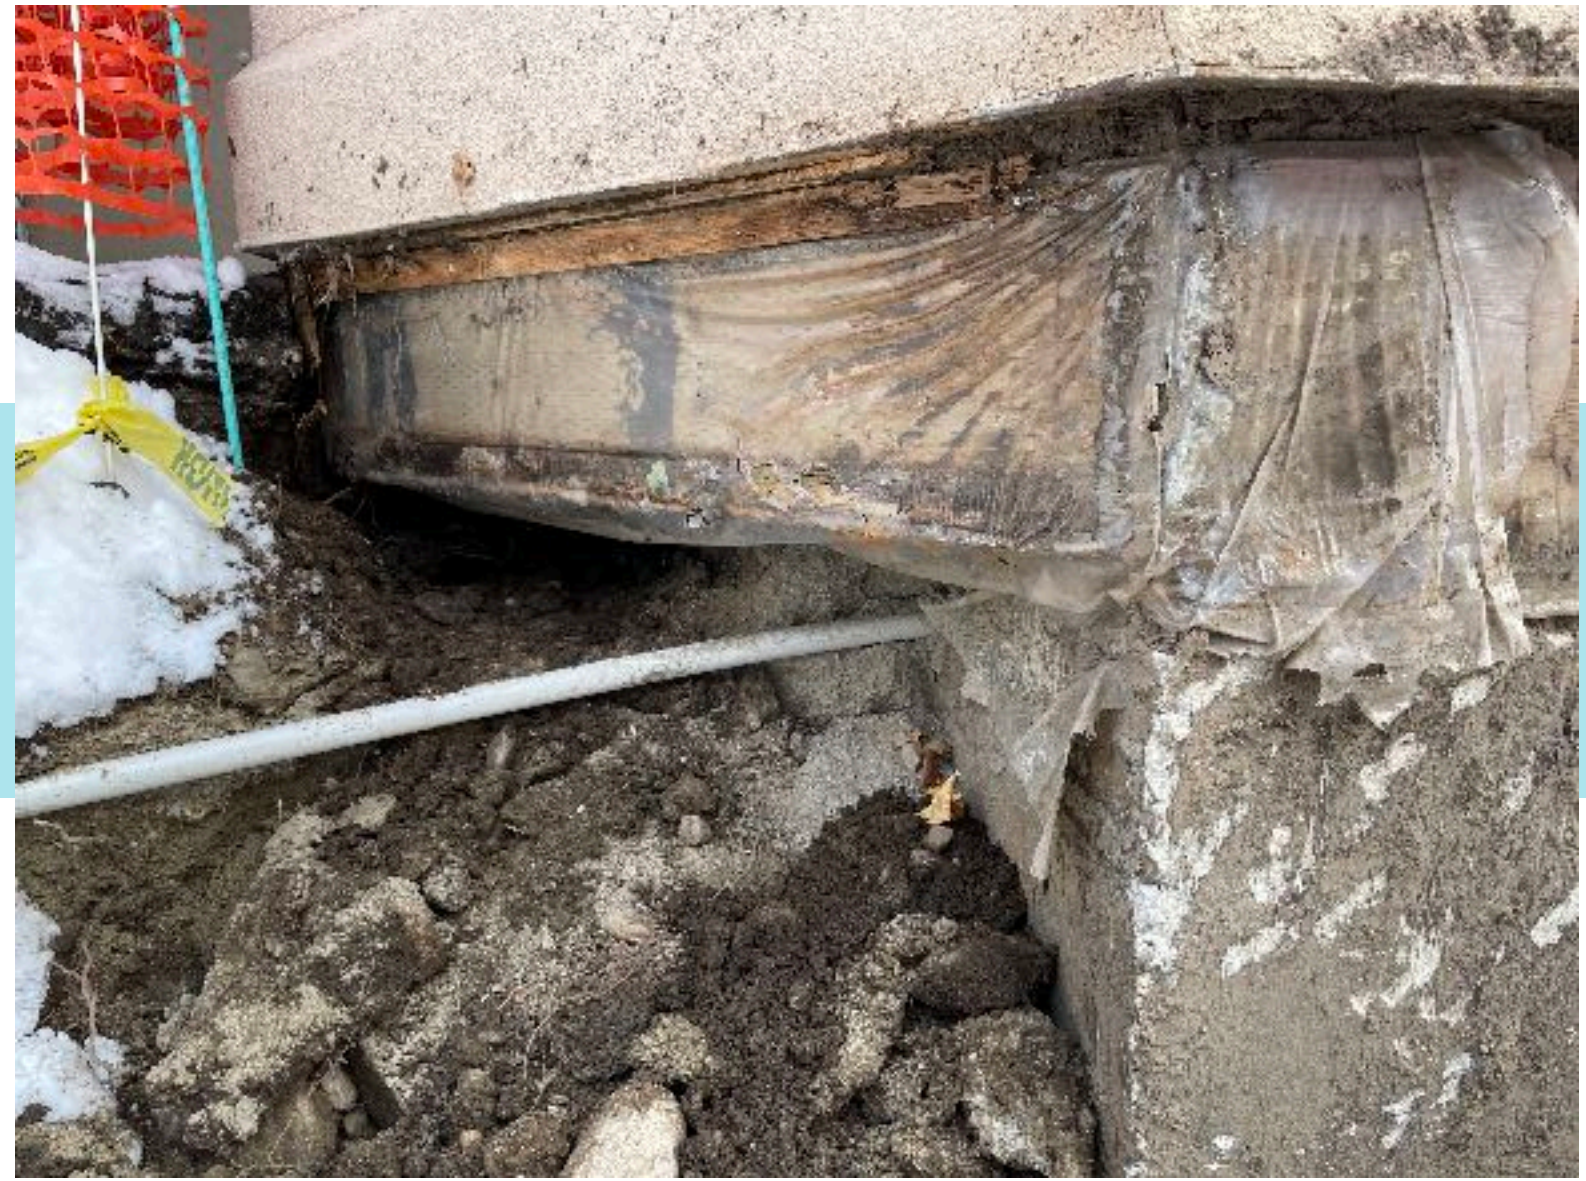
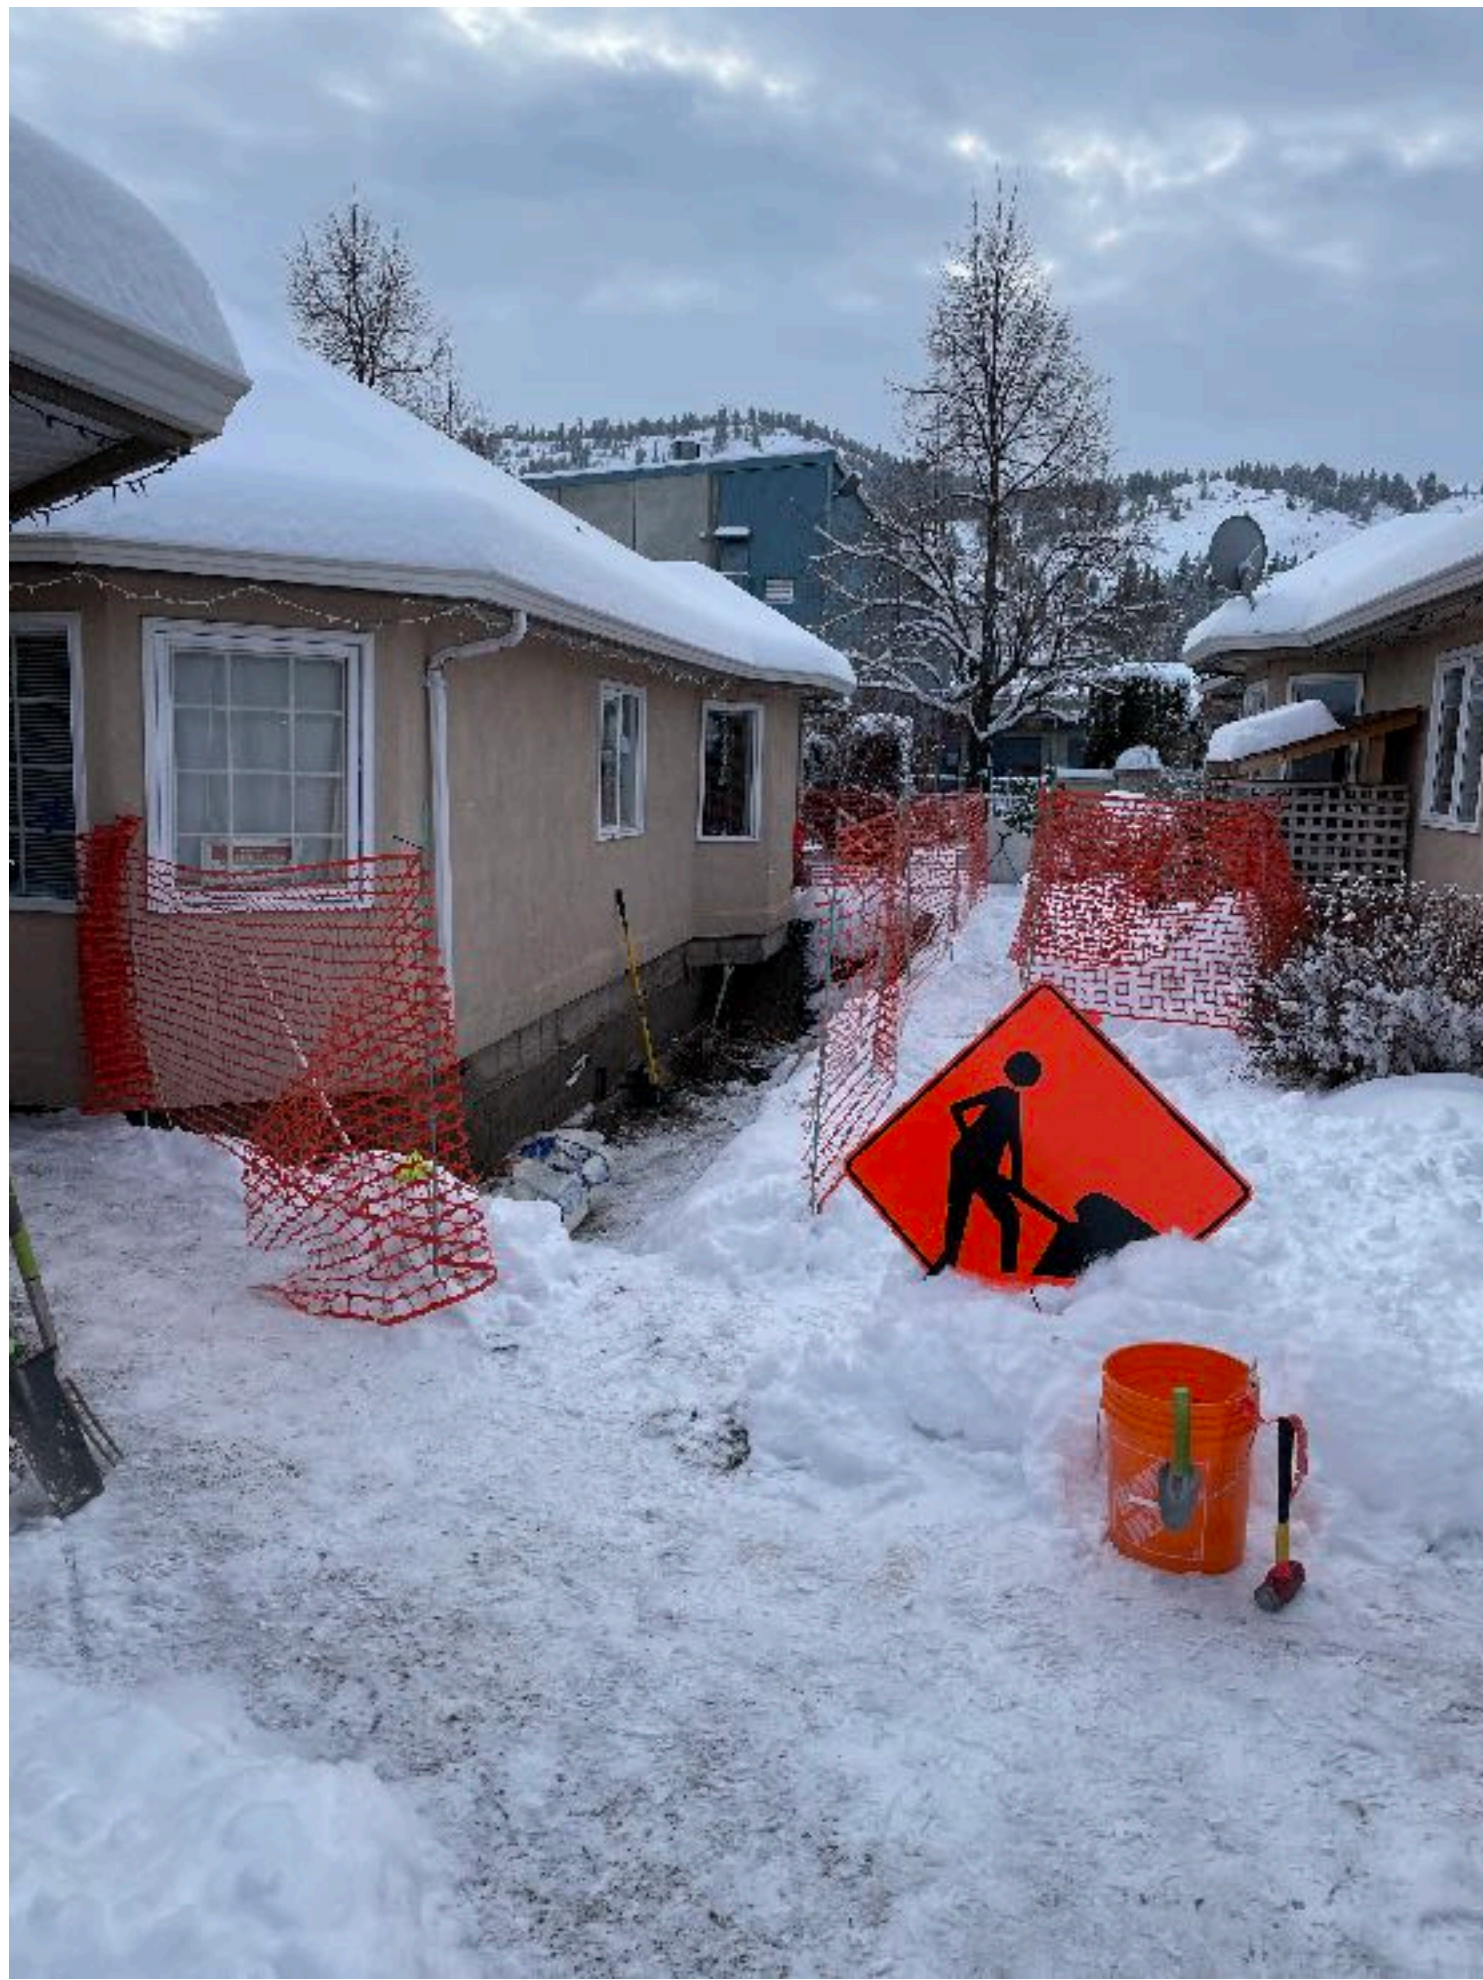
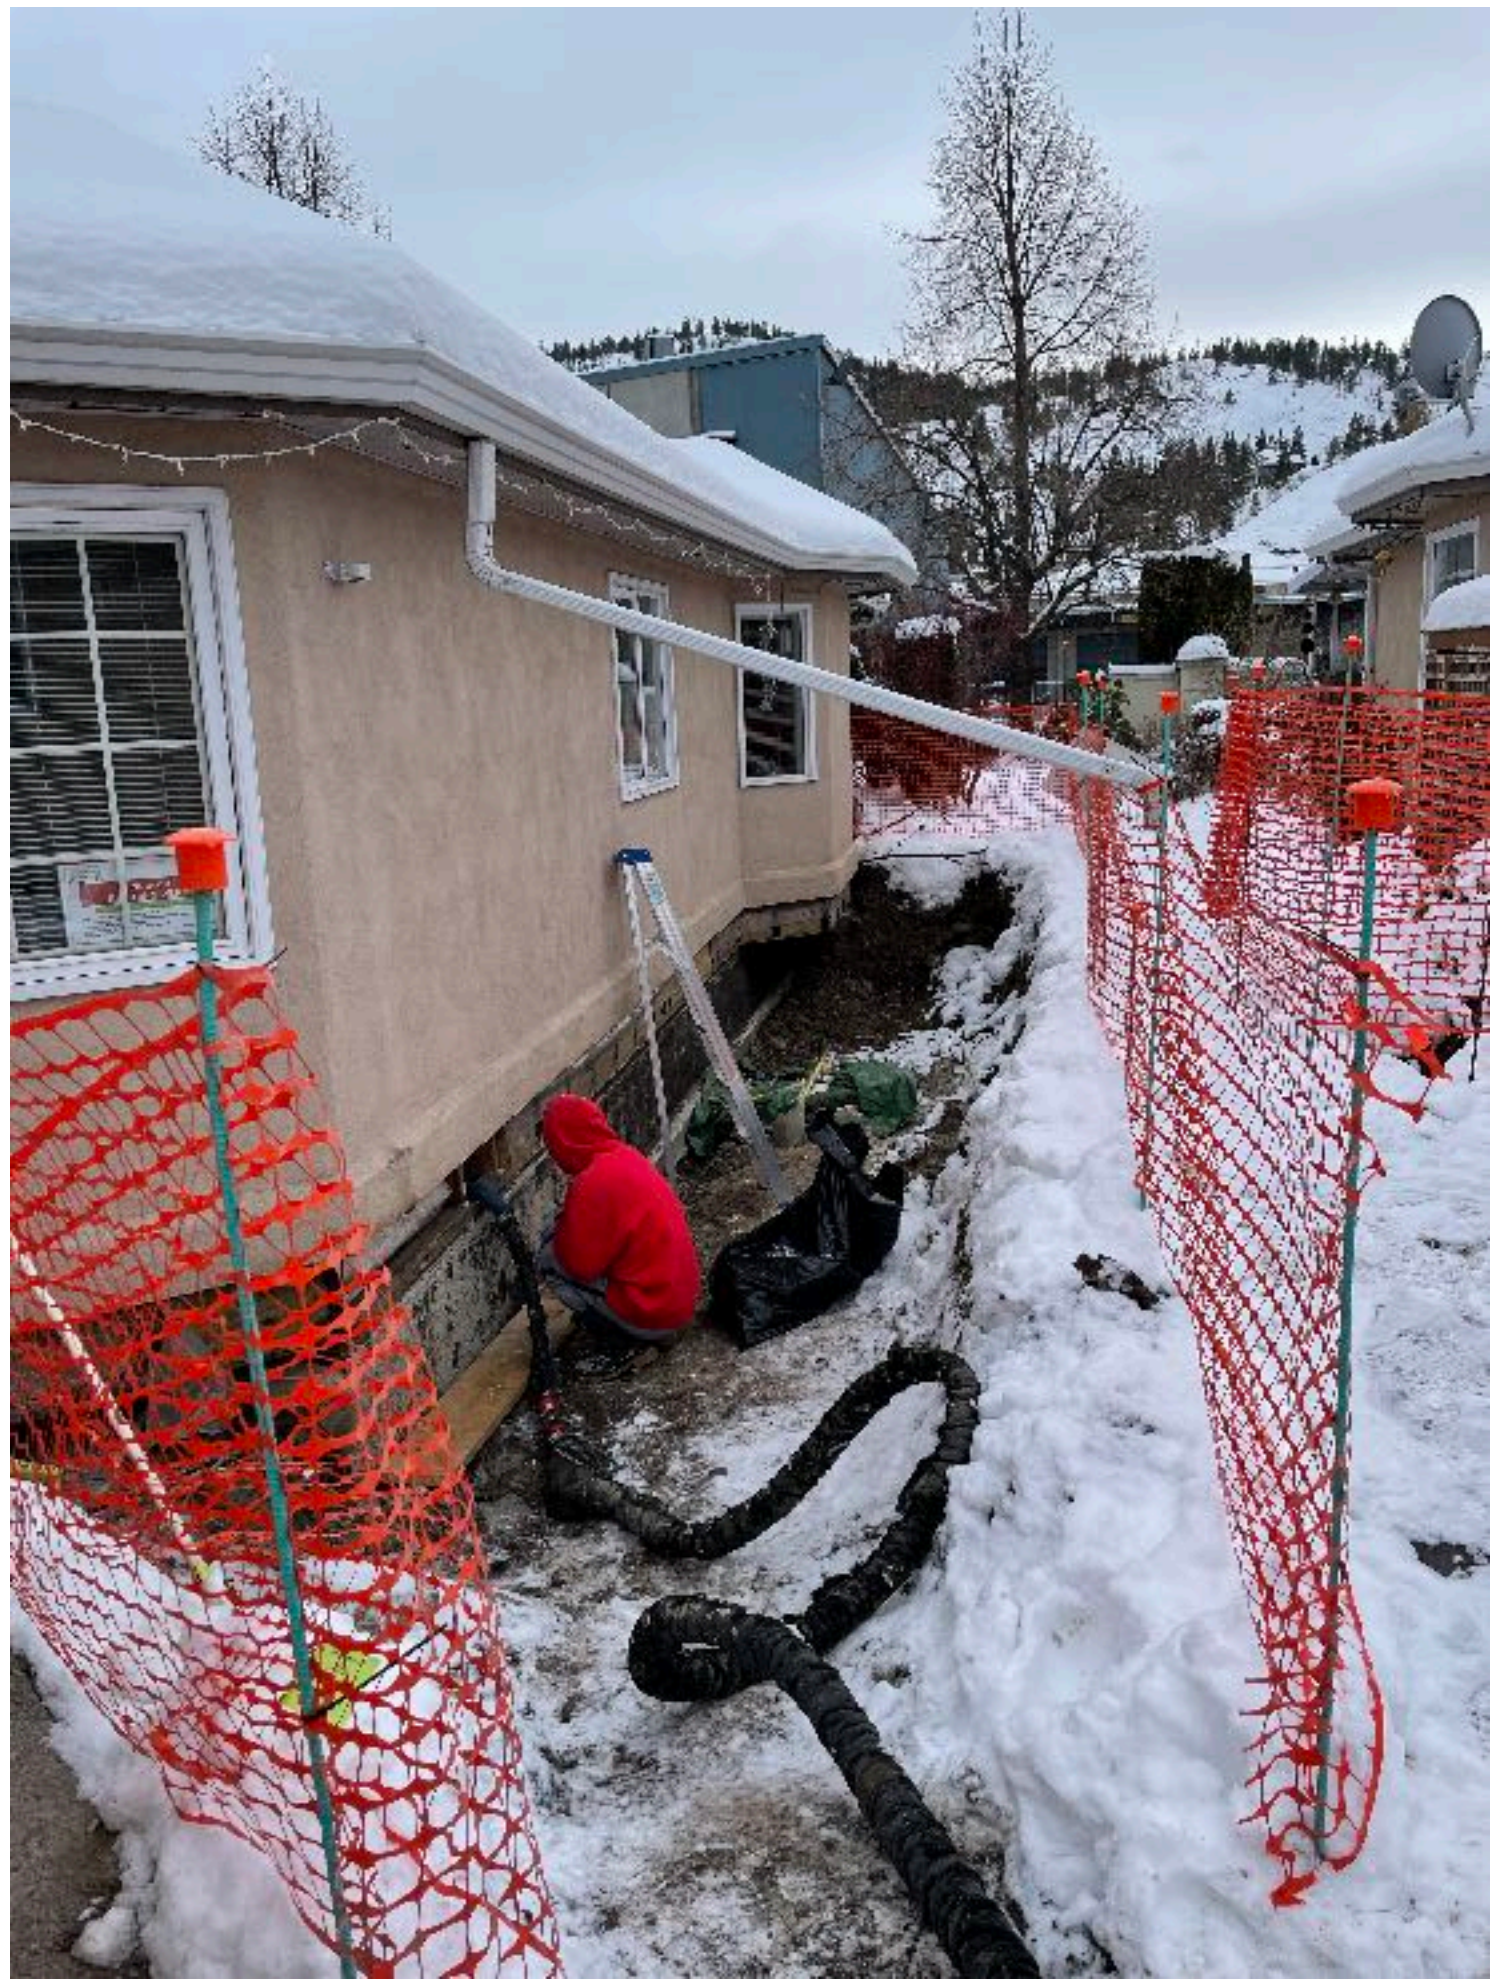
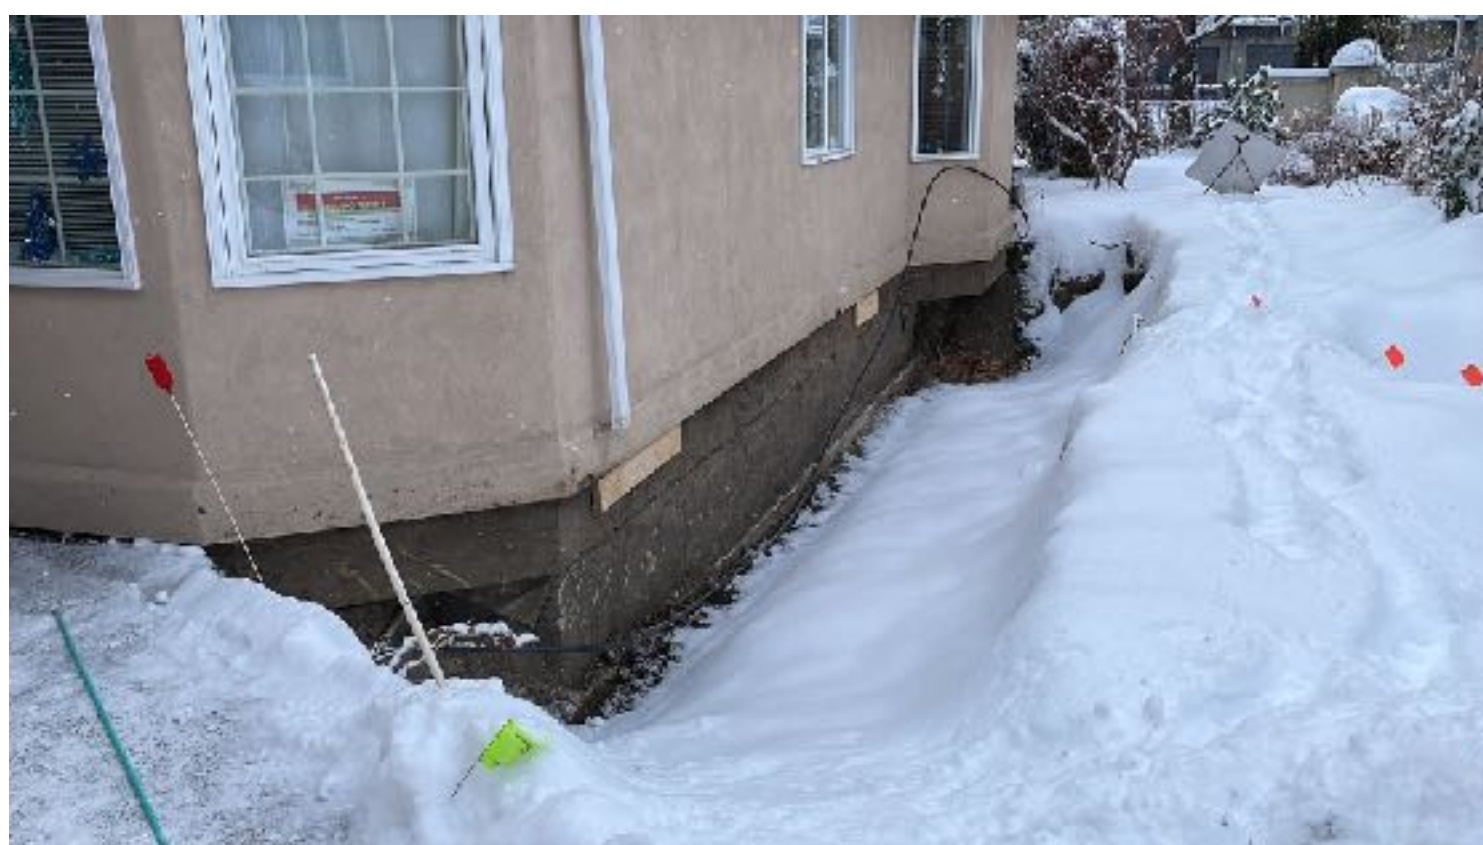
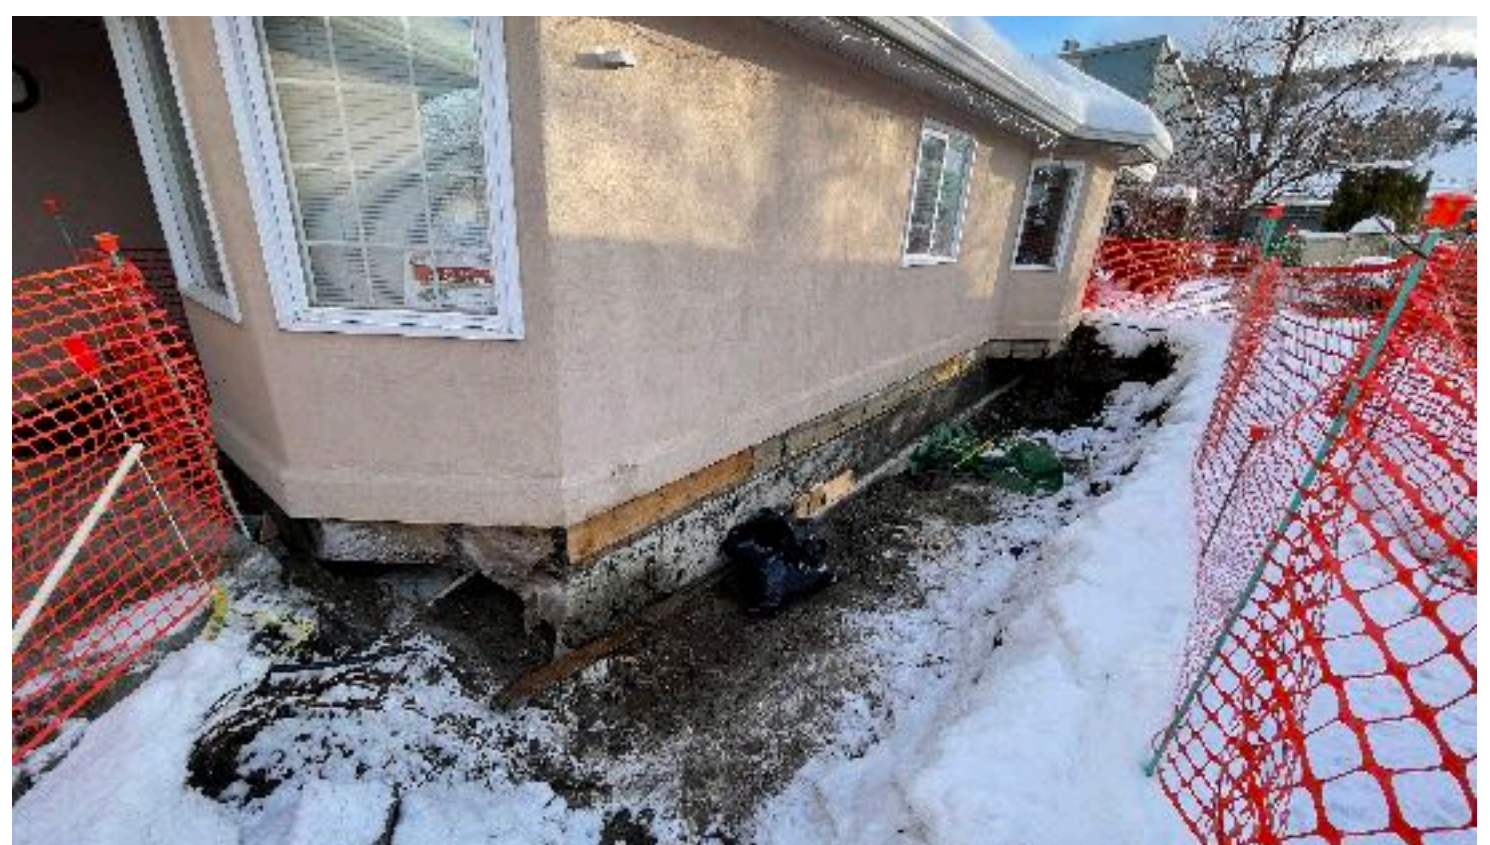
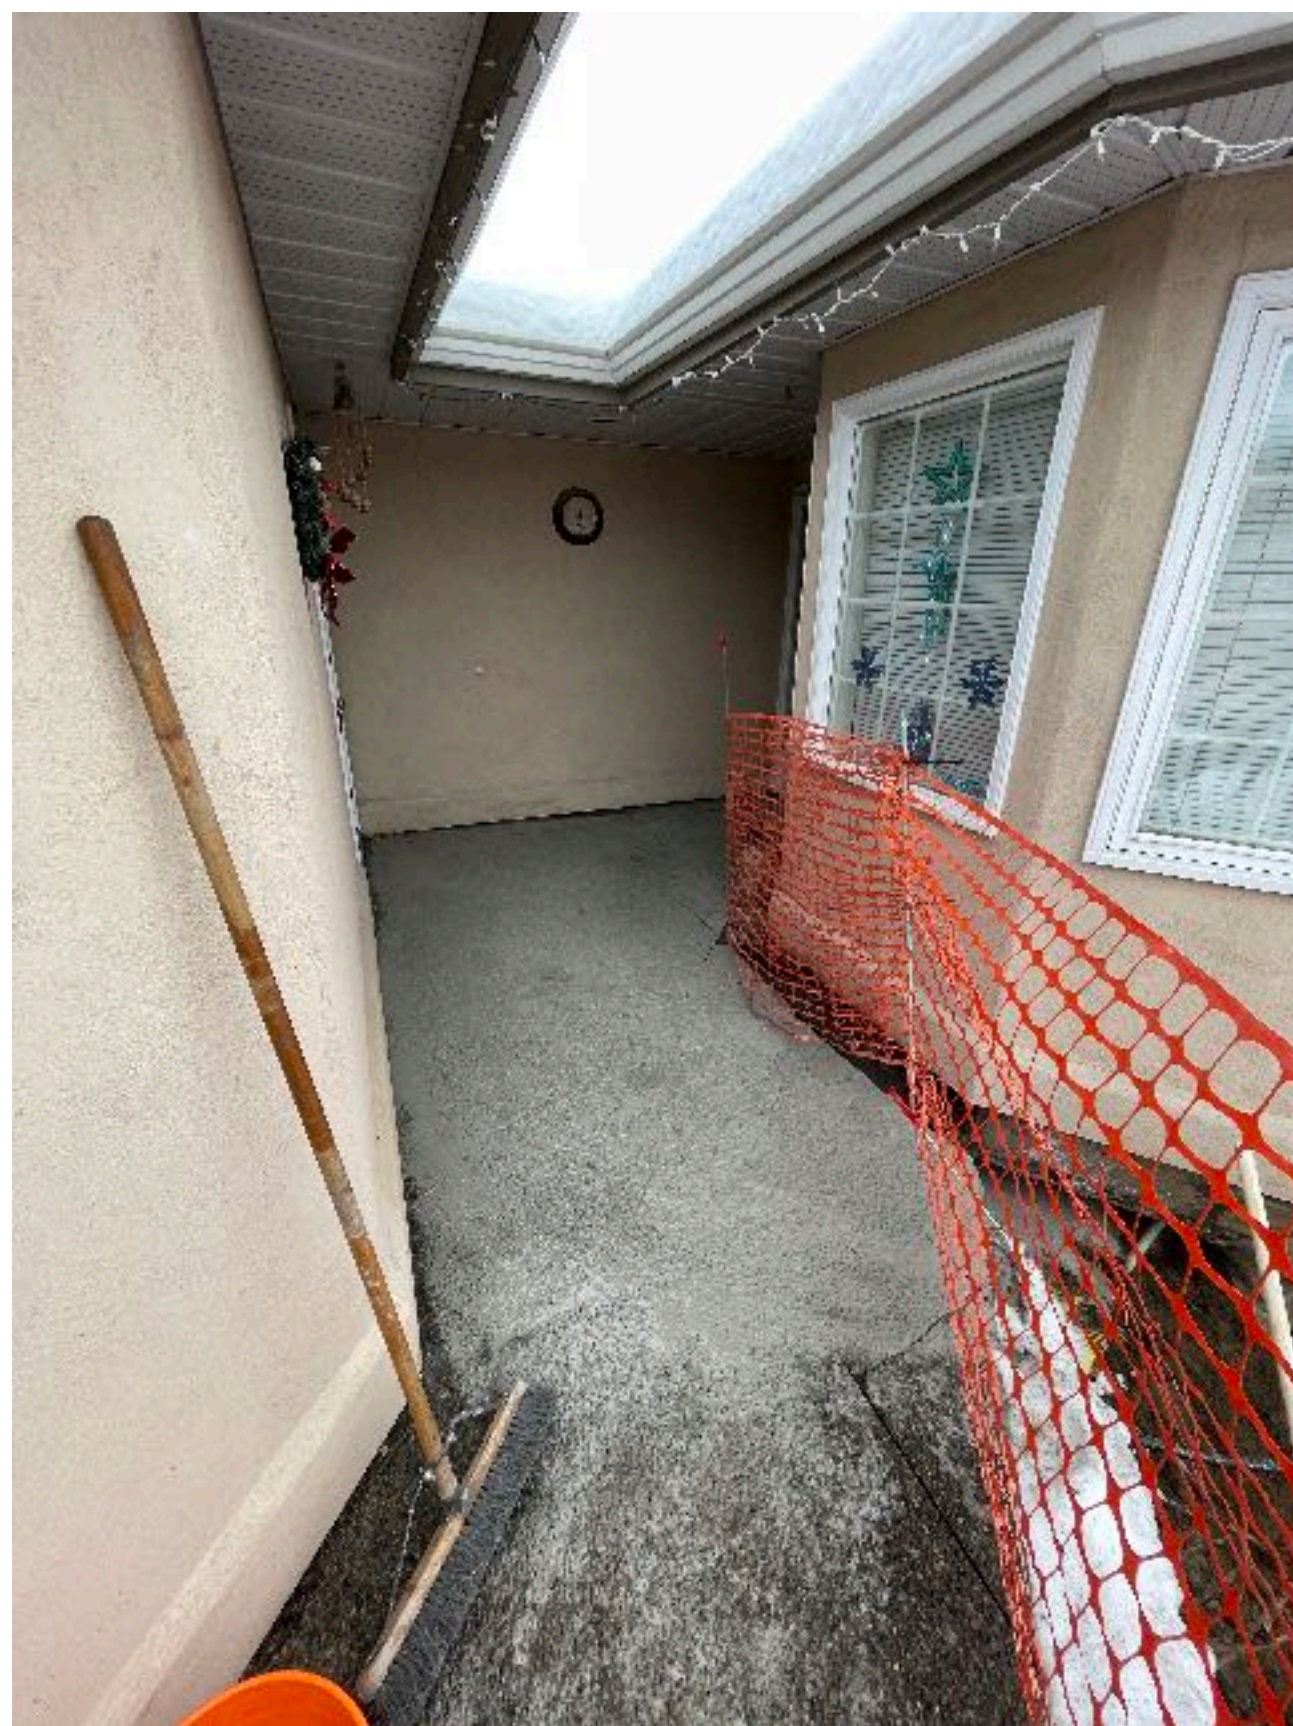
The concrete walkway up to the front door needed to be cut in order to expose a working cavity for the structural repair.

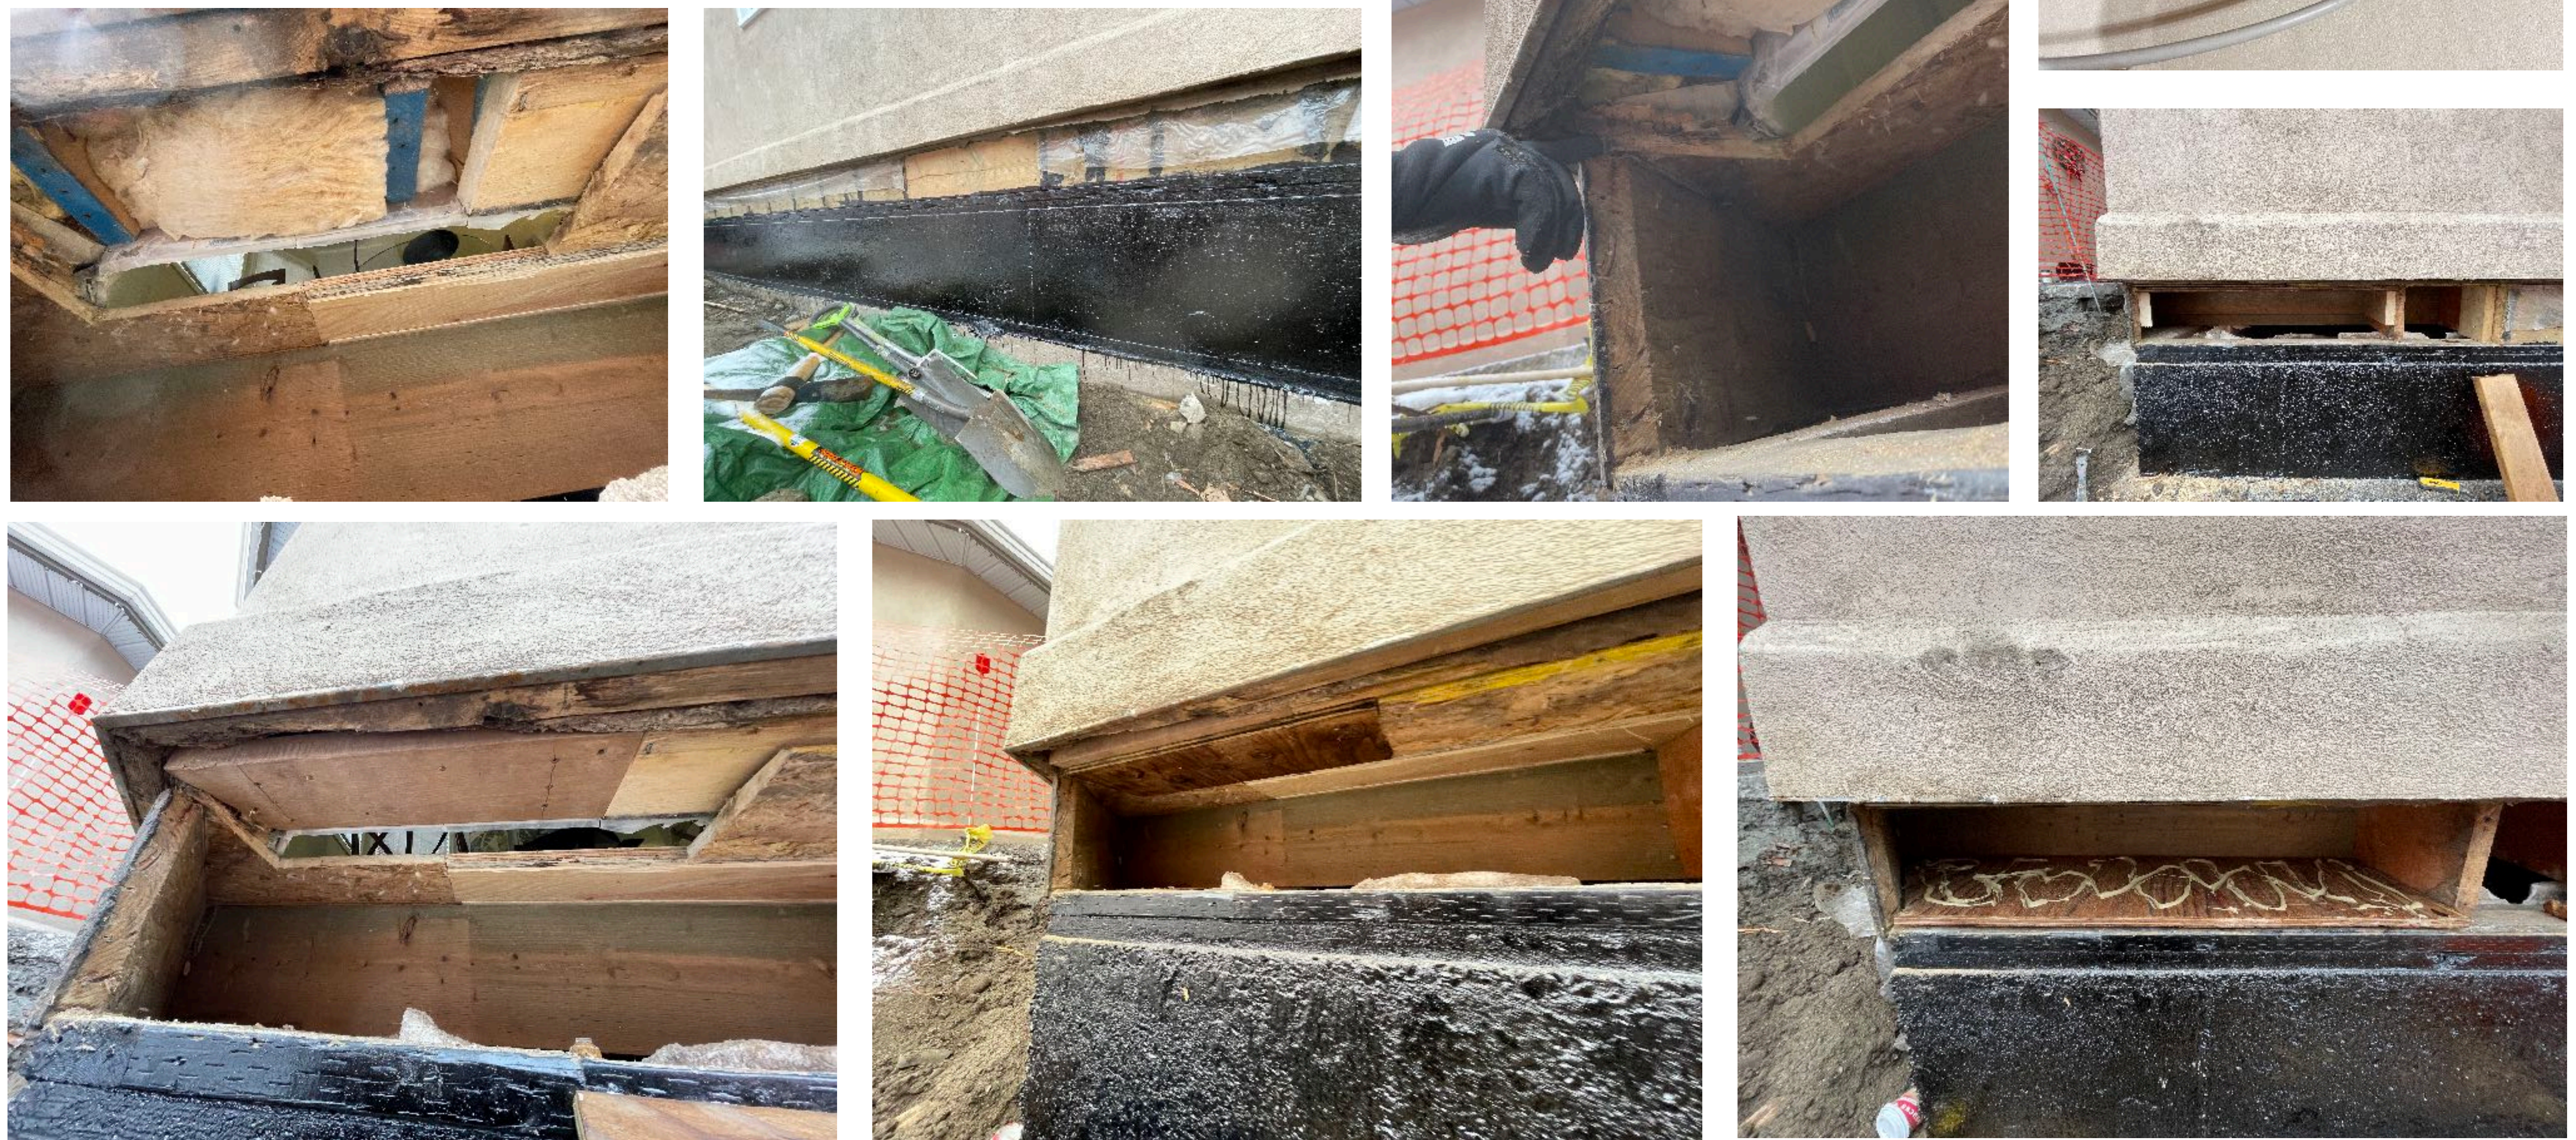
The rotten sections of the joists and wall plates needed to be removed and rectified in place.
